# Changing the Face of Construction

**High strength composite technology protects masonry buildings.**

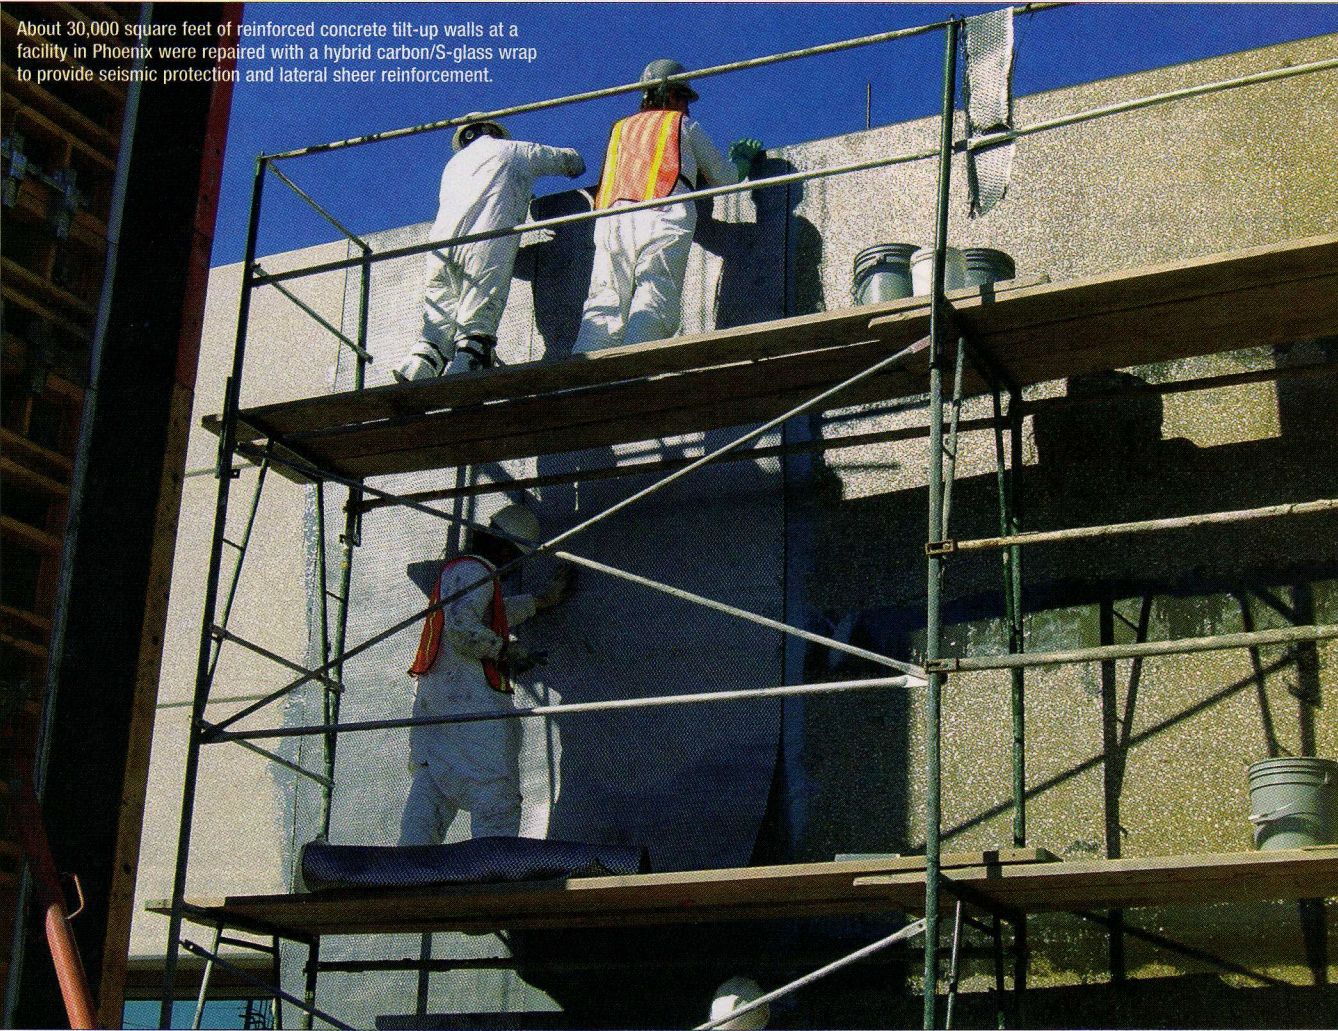
About 30,000 square feet of reinforced concrete tilt-up walls at a facility in Phoenix were repaired with a hybrid carbon/S-glass wrap to provide seismic protection and lateral shear reinforcement.

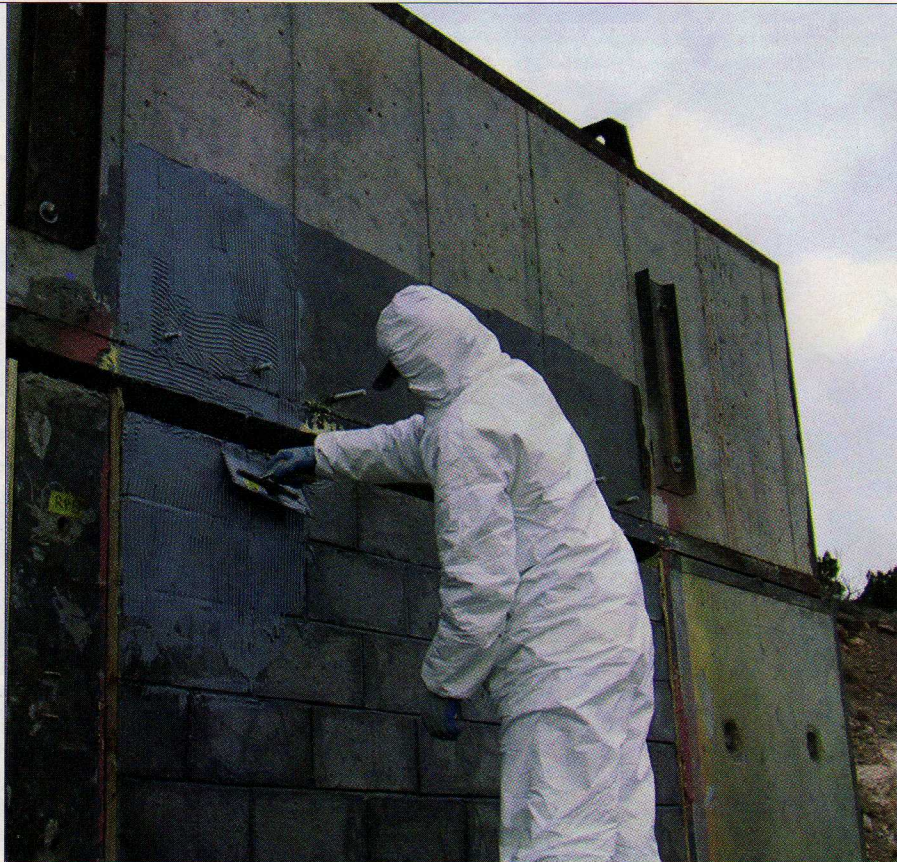
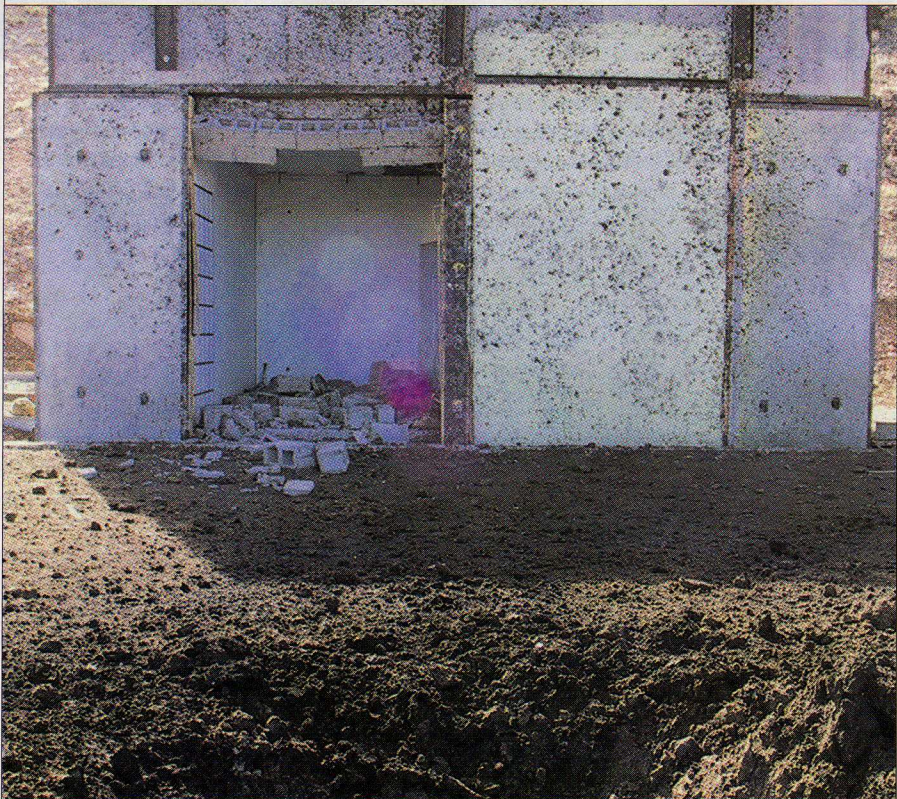
In testing sponsored by the Department of Defense, two unreinforced concrete masonry walls were constructed within a larger containment structure, with each wall being 8-ft. wide x 11-ft. high. One wall served as the control specimen (below left), and the other was retrofitted with Blastek inside and outside (above and below right). A TNT explosive blast destroyed the control wall, while the protected one remained intact.

In testing sponsored by the Department of Defense at the Energetic Material Testing and Research Lab in New Mexico, 212 pounds of TNT were detonated 33-ft. away from two unreinforced masonry walls – a control specimen and a wall retrofitted with Blastek. The explosion created a blast wave at the face of the unreinforced masonry walls that measured a peak load of 180 psi.

Upon impact, the control specimen was obliterated, but the wall retrofitted with Blastek remained completely intact. The system allowed only 1.4 of the 180-psi force to transfer to the other side. Following the explosion, vibration in the wall quickly attenuated and it came to rest in the original position.
